HYDROGEN READY POWER PLANT

GEK 116662e
Revised, Feb 2022

Operation and Maintenance Recommendations for Gas Turbine Exhaust Diffuser Ducts

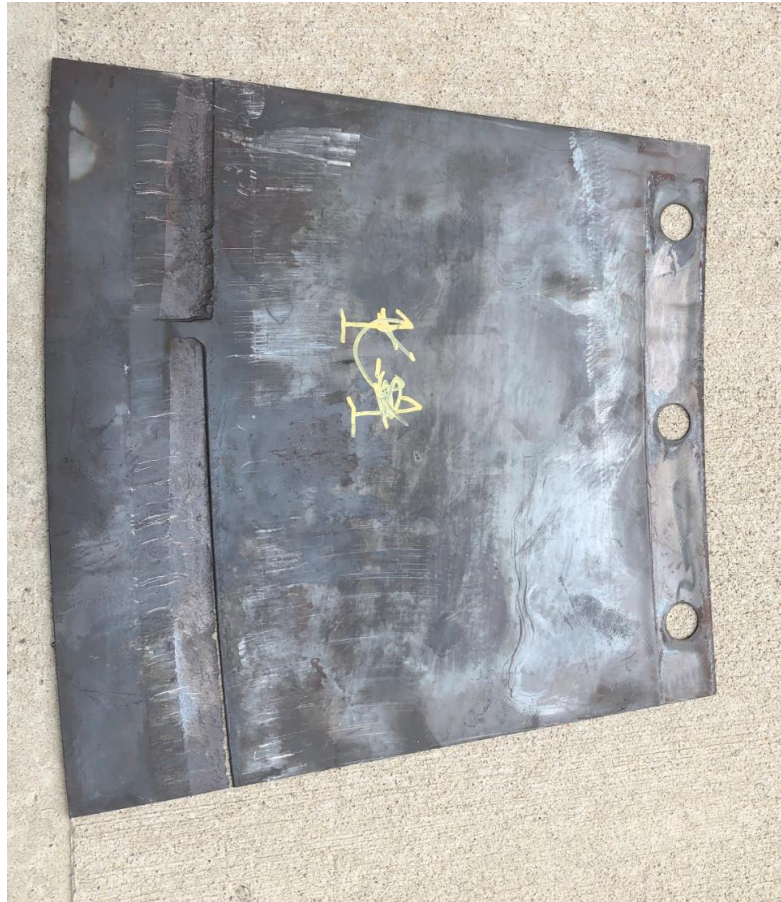
- Inspect the metal backing bar, clamping bar and hardware on the flex plates for tightness.
- Look for cracks or wear on flex plates.
- Ensure that all clamp plates that are in contact with the flex seals in either the “hot” or “cold” positions have broken edges (rounded corners) where the clamp interfaces with the flex seals. See Figure 4. For more information, please refer to Figure. 16 ANEX C.

Figure 4. Flex seal wear due to sharp edges on flex seal clamp plates

Flex plates must be replaced if wear or cracks are found on surfaces. The replacement must conform to GE's process or that from the qualified vendor. Contact the local GE Energy Services representatives for all concerns.

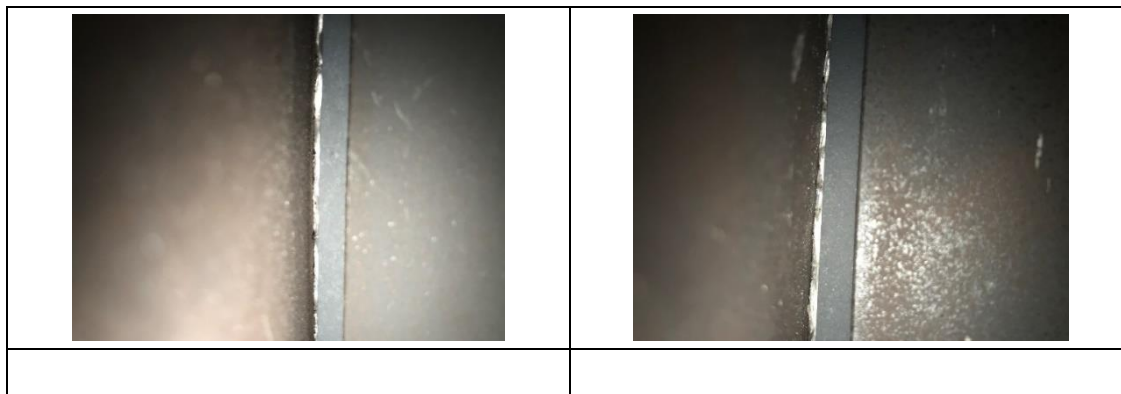
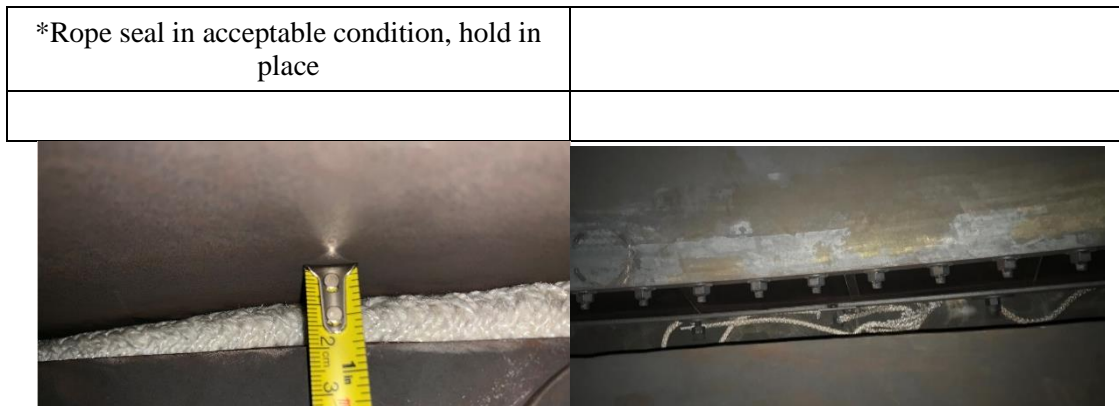
- Scaffolding will need to be erected within the exhaust to have access to all sections of the A042 Exhaust Diffuser for inspection.
- Using a mirror, inspect the full circumference of the rope seal to ensure the rope seal is entirely in place and there are no missing sections. Figure.8 are some example photos of what should be seen with the inspection mirror. Example photos of rope seal out of position.

Figure.8 *Rone seal in unaccetable condition. out of position

Rope seal replacement installation:

- Prior installation, make sure the adjacent area is free of moisture, dust, contamination and any other exogenous material (including grease), rope braiding allows for particle entrapment, leading to potential heterogeneities detrimental to thermal behavior.
 - Prevent unnecessary bents on the rope seal, particularly during handling and installation.
 - Avoid usage of sharp-edge tools (screws, knives, plates, etc.) to get the rope-seal in position. Rope Seal
 - Plan installation to place the seal in a single-continued operation, meaning final plate installation will result in a one-pressing operation making the splice at the bottom section of the A042 duct.
- 1) Cut the **rope seal** to the exact dimension to cover the exhaust diffuser circumference making the joint at the bottom section.
 - 2) Peel off 14" - 16" of side A

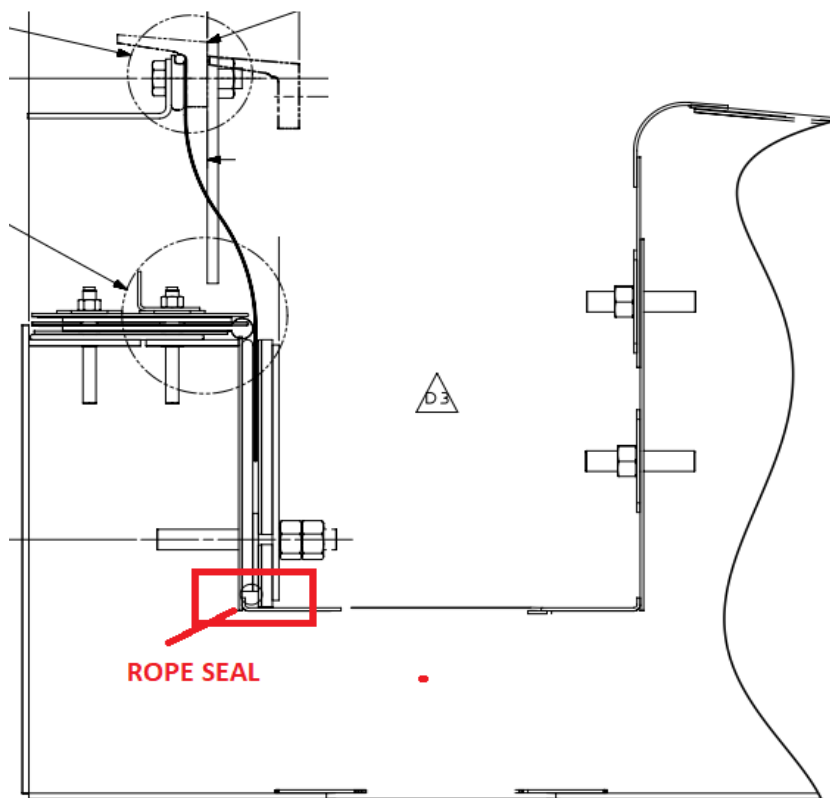
Figure.9: Rope seal is compressed and set in position all around the A042 by the 3rd layer clamp.

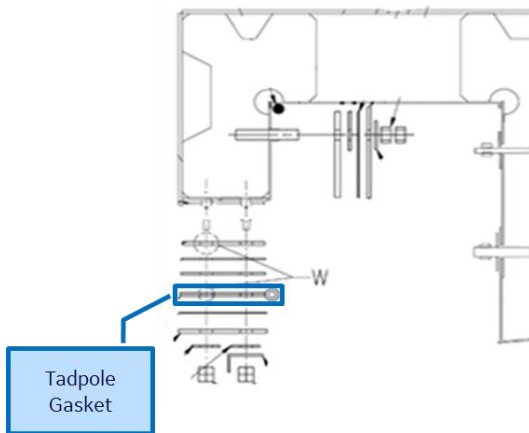
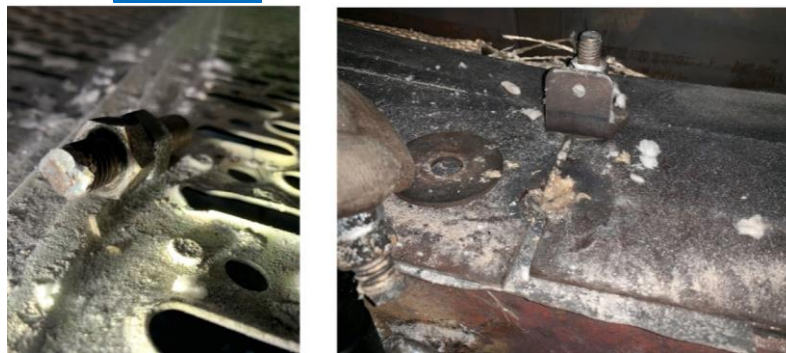
- Inspect the tadpole gasket to ensure it is installed in the correct orientation shown in Figure.14 . If tadpole gasket, hardware or tadpole clamp plates are not installed properly or worn out a new tadpole gasket, hardware or clamp plate need to be installed/replaced correctly.

Figure.14: Broken bolt

- Broken bolt needs to be repaired as per GEK116662, section IV.

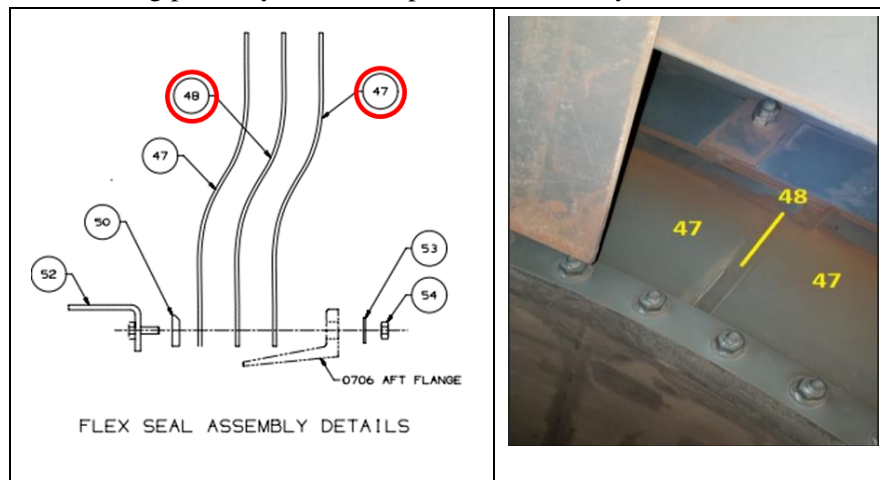
Visually inspect the first two (2) layers of flex seals #47 and #48 circled in red in the drawing Figure.15. These inspections should be performed from inside the exhaust checking for any of the indicators listed below.

- Discoloration
- Fractured/broken
- Distortion
- Buckling
- Gaps and/or foreign material between the first 2 layers of flex seals (#47 & #48) which prevent the first layer (#47) from sitting perfectly flush on top of the second layer (#48).

Figure.15: Visual inspection of the first two (2) layers of flex seals

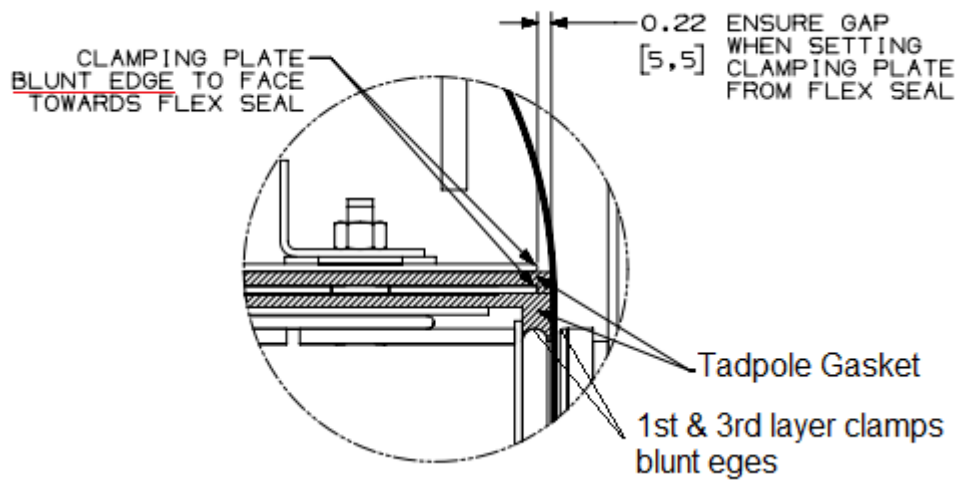
Perform same Inspections from outside (Figure.16 : examples photos of findings for repair)

Figure .16 : Tadpole clamp plates and 1st and 3rd layer clamps edges

- Inspect the 6.4 mm [0.25 in] radius at the AFT flange of MLI 0706 (near flex seal).
 - If not provided, make this radius by field grinding.
- Remove sharp edges on 1st layer , 3rd layer clamps, tadpole clamps and shims Figure 16
- Check if 0706B flange has no sharp edges, if flange has sharp edges then grind the edge as shown in fig.5
- Tadpole gasket bulb must face towards the flex seal tadpole gasket axial position to be set such that bulb is flush with the flex seal with no gap all over the 360 length. Tadpole gasket outer clamp plate shall compress the gasket bulb. Tadpole gasket outer clamp shall not touch the flex seal sheets

*Verify that tadpole clamp plates and 1st and 3rd layer clamps edges are rounded as shown on the picture if not rounded already from factory.

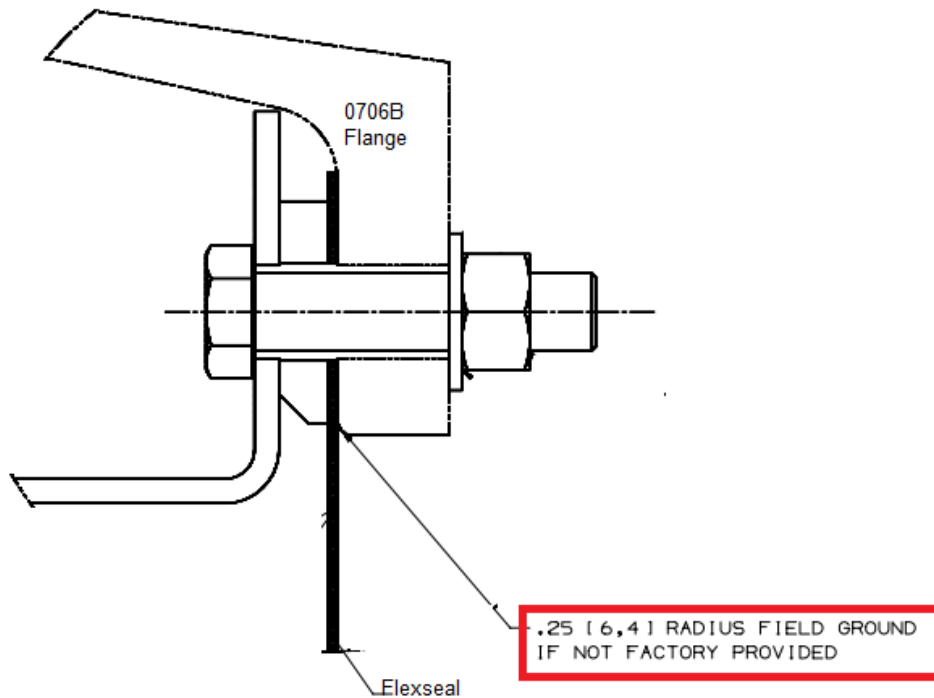
- Figure:5 Inspect that outer flex seals surface for any damage due to the tadpole gasket clips being installed backwards or buckling as shown in Figure.18

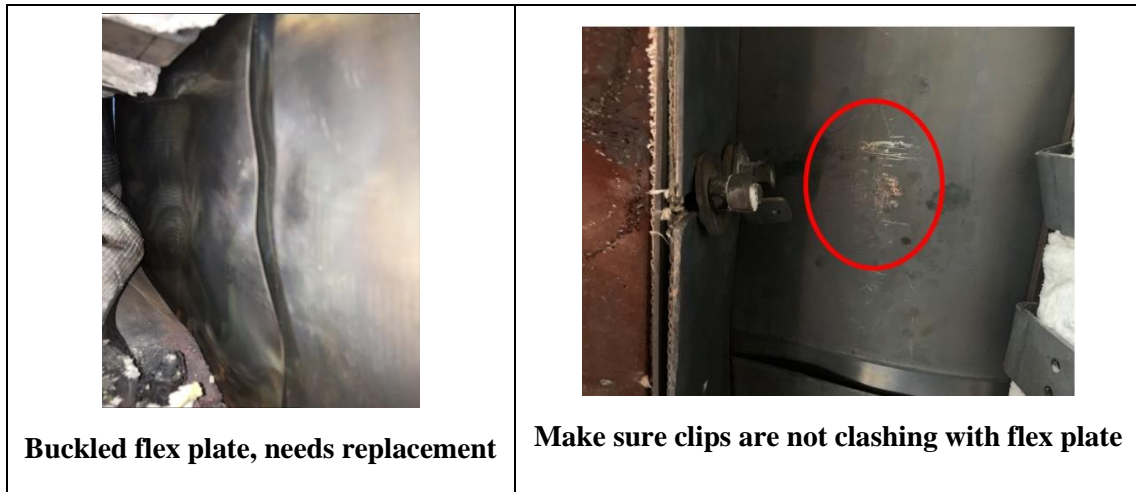
Figure.18: Hardware Inspection

- Inspect for any missing/loose hardware (nuts, broken studs, etc.) The broken bolt needs to be repairs as per GEK116662, section IV.
- The torque of the third layer clamping bar nuts should be properly torqued following the double nut method in Figure.19.

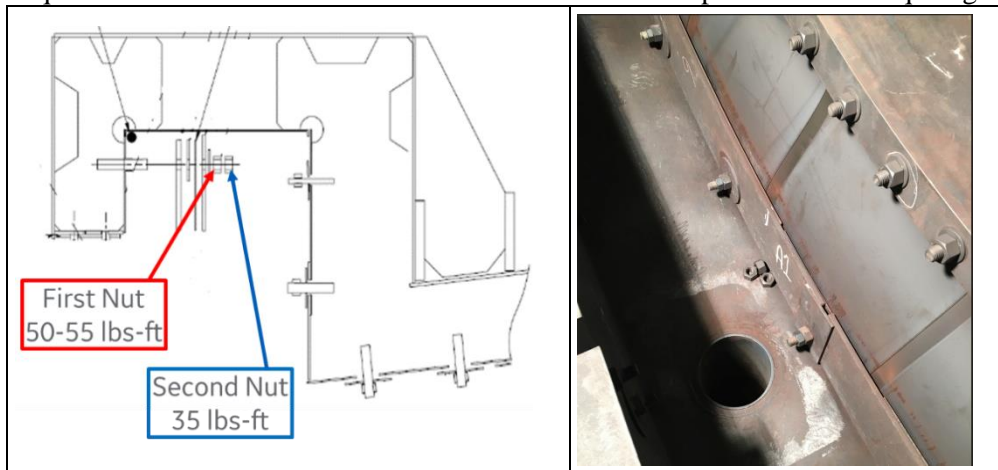
Figure.19: Hardware Inspection

Install all the first nuts and torque them to 50-55 ft-lbs [68-75 Nm] using a calibrated torque wrench. Repeat tightening the nuts a second time to 50-55 ft-lbs [68-75 N-m]. Use a wrench to hold the first nut and prevent it from rotating and install/torque the second nut to 35 ft-lbs [47-N-m] using a calibrated torque wrench. Stud must be lubricated with anti-seize compound before torquing.

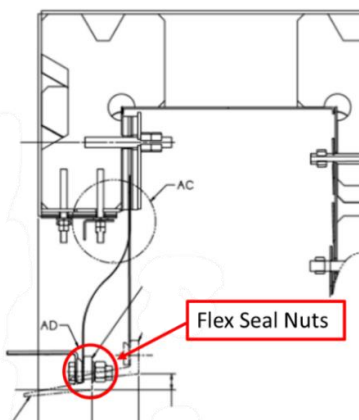
- The flex seal hardware should be inspected to ensure that all the flex seal nuts have been tack welded. If any nut is not tack welded, then retorqued using the torquing method in Figure.20.
- Torque flex seal hardware 75 to 80 ft-lbs. After 3-5 gas turbine starts retorque to 75 to 85 ft-lbs. and tack weld nuts. Stud must be lubricated with anti-seize compound before torquing.
- Records of the retorquing of the flex seal clamping hardware after 3-5 starts.

Figure.20: Flex seal clamping hardware
